Siemens Traffic Controls,  
Sopers Lane,  
Poole,  
Dorset,  
BH17 7ER

SYSTEM/PROJECT/PRODUCT: Helios

## HELIOS COMPATIBILITY

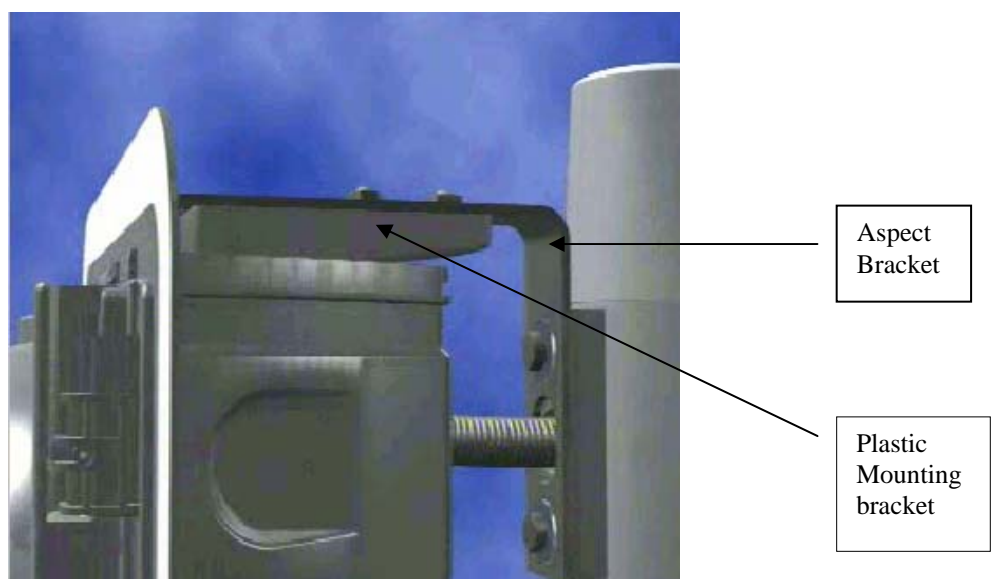
**Top Aspect and Plastic Mounting Brackets**

Early 1 aspect, 2 aspect and 3 aspect brackets were made of 5mm material and along with the 4 aspect mounting bracket had an 18mm slot for connecting to the plastic head mounting brackets (667/2/30052/003). Later 1 aspect, 2 aspect and 3 aspect brackets were made of 6mm material and the slot for connecting to the plastic head mounting brackets was reduced to 11mm for the 1, 2, 3 and 4 aspect brackets. Along with this change the plastic mounting brackets were changed. If an original bracket requires changing, then both the aspect bracket and the plastic mounting bracket need changing.
