USE OF ST950 FIRMWARE AND HARDWARE CONFIGURATIONS 667/SU/46000/000

Security classification	Unrestricted	Page	1 of 25
Version	9	Status	Issued
Last Editor	harry.smyth	Date	25-Jul-2018
Document Name	ST950 F/W & H/W Configurations	Document No.	667/SU/46000/000
Copyright © Siemens plc 2018. All Rights Reserved.		Mobility is a division of Siemens Plc

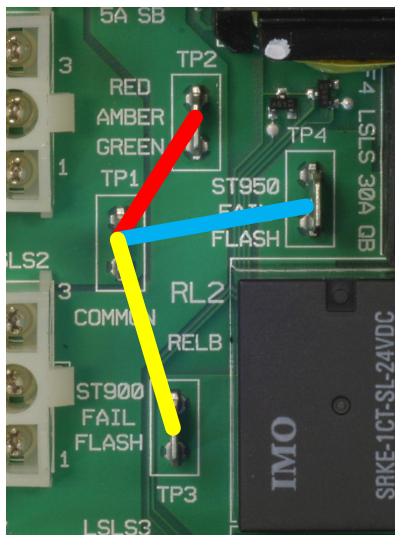
3.3.2 HPU PCB (High Power Unit) – 667/1/33041/xxx

The HPU PCB includes a number of link positions used to set up the controller to either fail to all signals off or fail to hardware flashing.

Issue 6 (or later) is needed for HFF (hardware fail flash).

The newer versions of the HPU PCB have an additional link position TP4 for 'ST950 FAIL FLASH'. The original HFF link position TP3 must not be in an ST950ELV controller.
